**NOTIFICATION**

**#0002**

**SUBJECT:** Wires overheating on Rotax 912 iS B-side voltage regulators

**MODELS AFFECTED:** All Sling LSA and Sling 2 aircraft fitted with Rotax 912 iS engines.

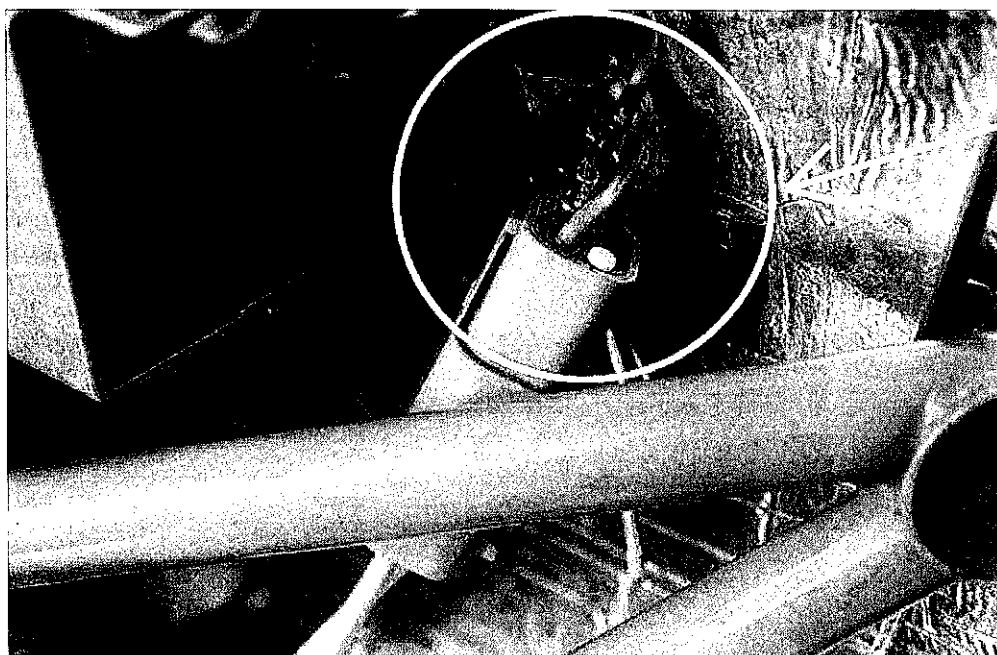
**PURPOSE:** There is a risk of failure of the B-side voltage regulator fitted to Rotax 912 iS engines due to overheating of the wires on the B-side voltage regulator overheating. This usually occurs at the grey connector.

The B-side voltage regulator (which powers all auxiliary equipment such as instruments and lights) fitted to the Rotax 912 iS needs to have current drawn from it in order to remain cool. Should no current be drawn then the excess energy is dissipated through the wires and connectors which overheats them.

In the photograph below the discoloration is evident. Note the brown color of the brittle overheated wires.

Discolored Wires

It is recommended that taxi, landing and strobe lights of Sling aircraft fitted with the Rotax 912 iS engine be kept in the "ON" position for the duration of all flights.

Before each flight the condition of the yellow wires running to the B-voltage regulator must be checked for discoloration. This can be done through the left-hand inspection door on the top engine cowling. (See attached photographs), with the exception of the following aircraft serial numbers:

Should melted wires be noticed, it is recommended that the aircraft not be flown and The Airplane Factory, TAF distributor or the nearest Rotax Service Centre be contacted for assistance.

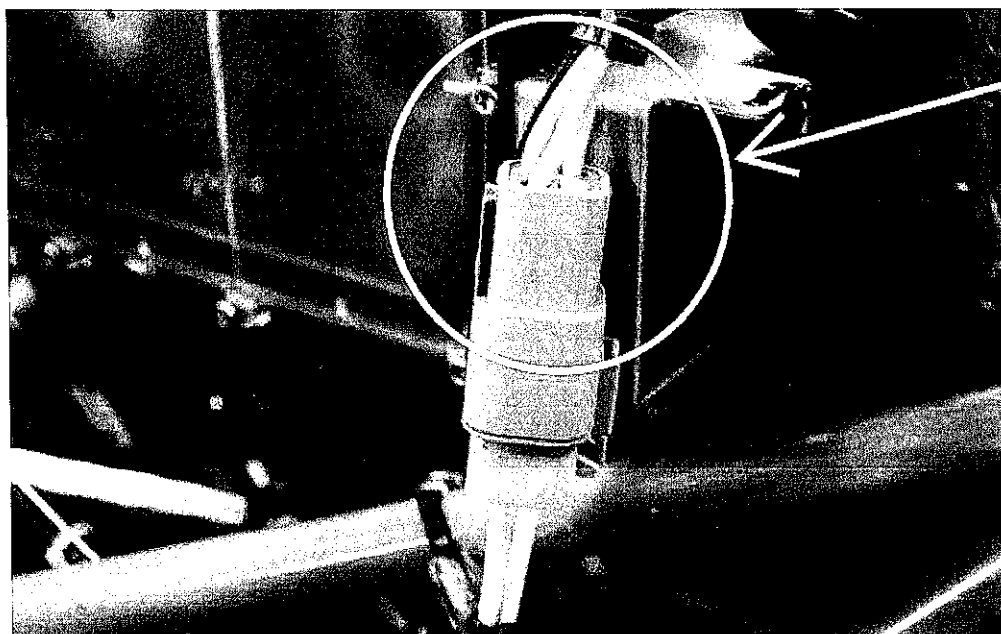
The photograph below indicates a normal voltage regulator connector plug.

Standard Color  
Wires
